**Test Report No. 7191035459-MEC12-OCS**  
**dated 27 Jun 2012**  
**(QM-0512-083Rev1)**

Testing of Office Chair submitted by Merryfair Chair System Sdn Bhd on 18 May 2012.

ANSI/BIFMA X5.4 – 2005 "Lounge Seating – Tests"

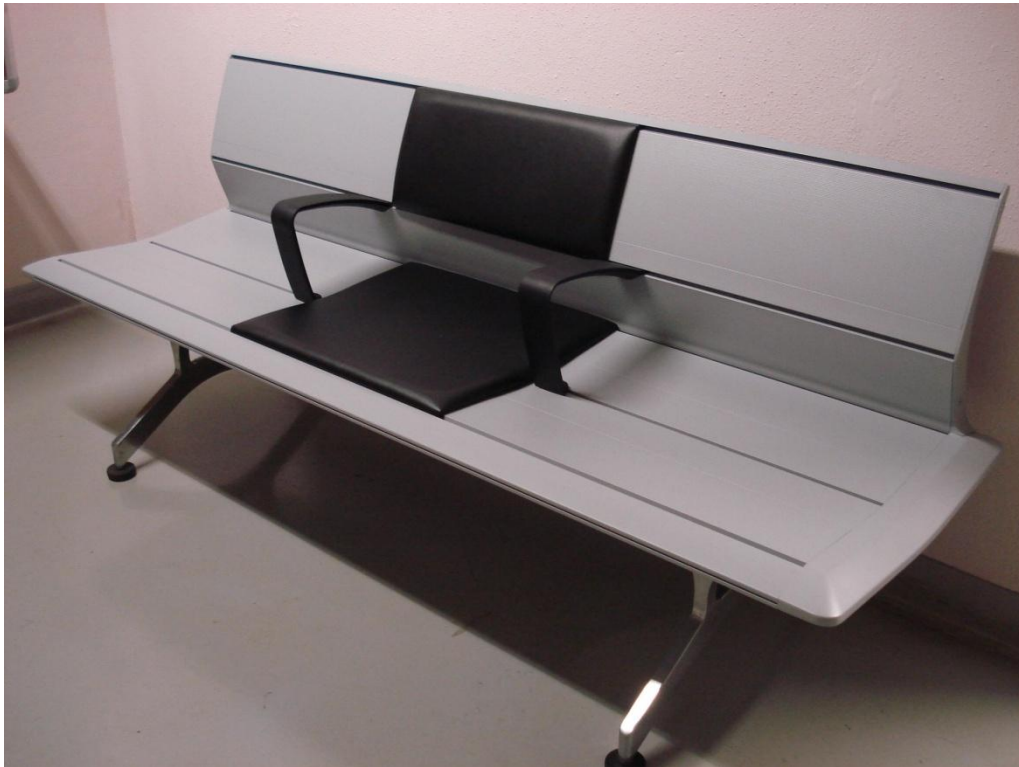
Photograph 1 : Silver Surf

One complete set of Office Chair as shown in the photograph 1 was received. The following descriptions were given by the client:

Model : Silver Surf  
Product Type : Lounge Seat  
Country of Origin : Malaysia
